WL-TR-94-4112

**THE SURFACE PREPARATION OF
ALUMINUM ALLOYS USING THE
PHOSPHORIC ACID CONTAINMENT SYSTEM
FOR REPAIR**

SEPTEMBER 1994

INTERIM REPORT FOR PERIOD 01 JUNE 1992 – 31 DECEMBER 1993

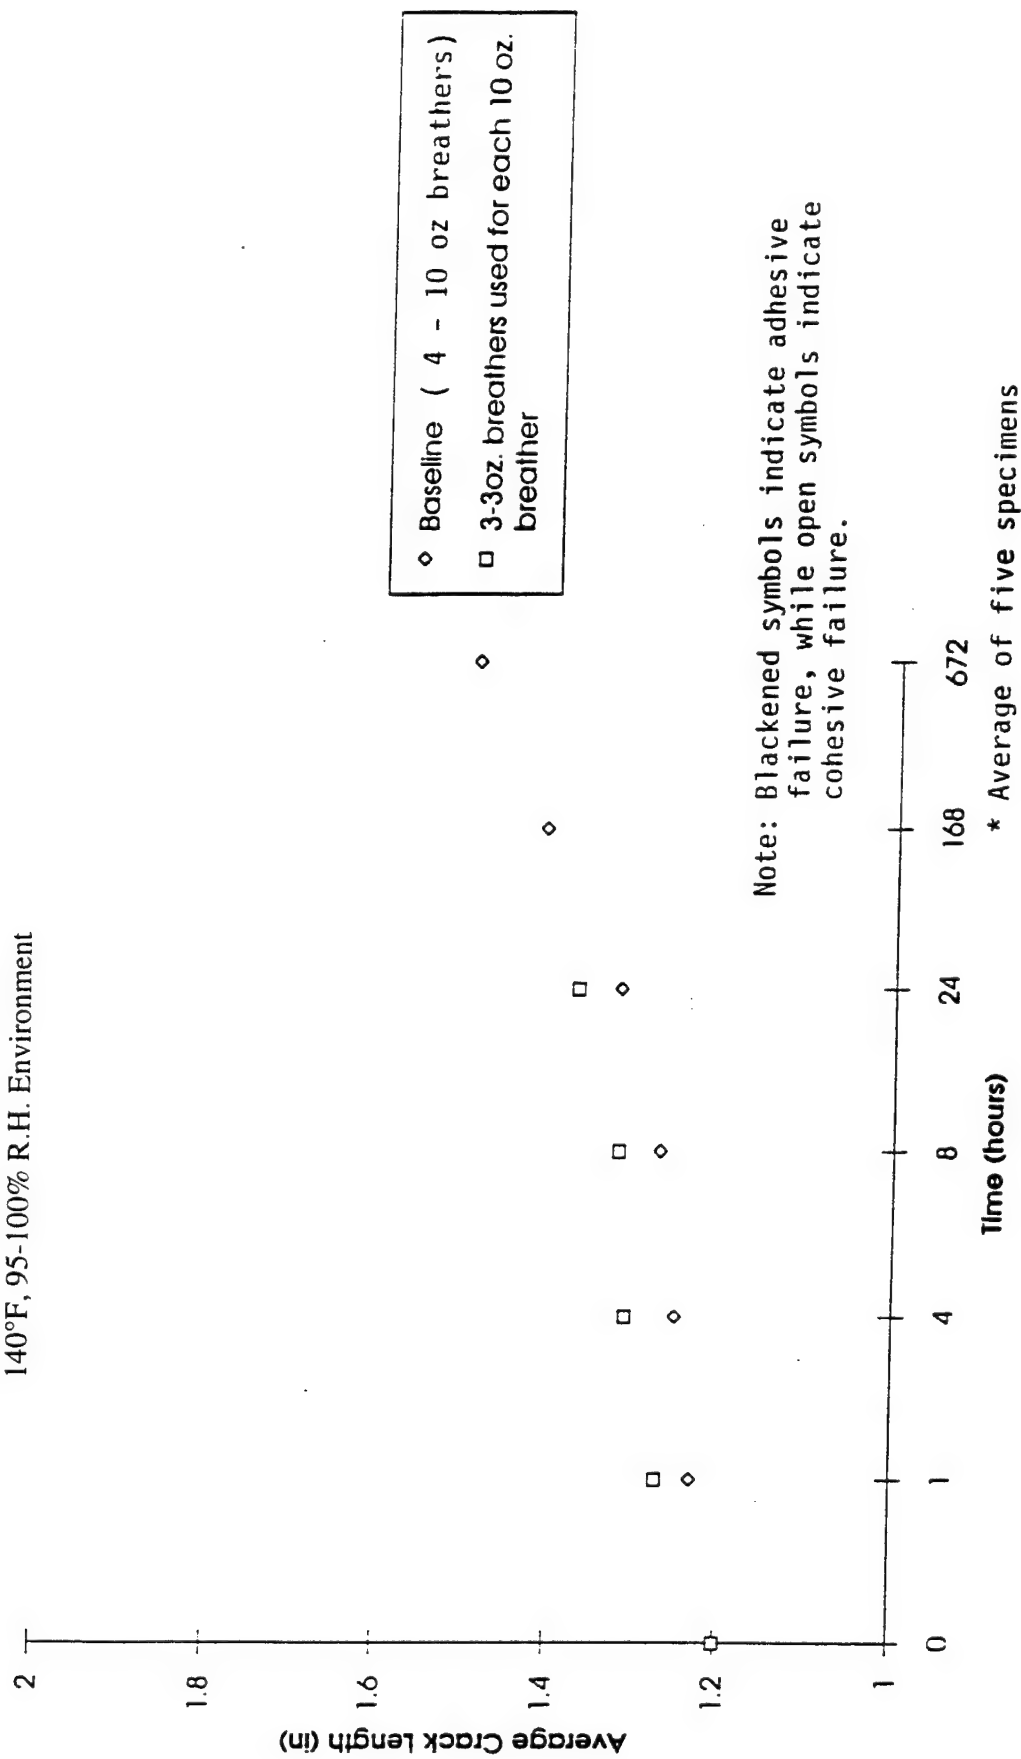
Figure 16. Effect of Type and Amount of Breather Material on Crack Growth Behavior of PACS Prepared Surfaces

AI 2024-T3 Bare/BR 127/FM 73
140°F, 95-100% R.H. Environment

The effect of breather material on the surface being anodized was evaluated. The current layup procedure requires the use of two 10-oz breather plies between the aluminum surface to be anodized and the screen and two 10-oz breather plies on top of the screen. Three 3-oz breather plies were substituted for each of these four 10-oz breather plies. The results presented in Figure 16 indicate essentially equivalent wedge crack growth behavior.

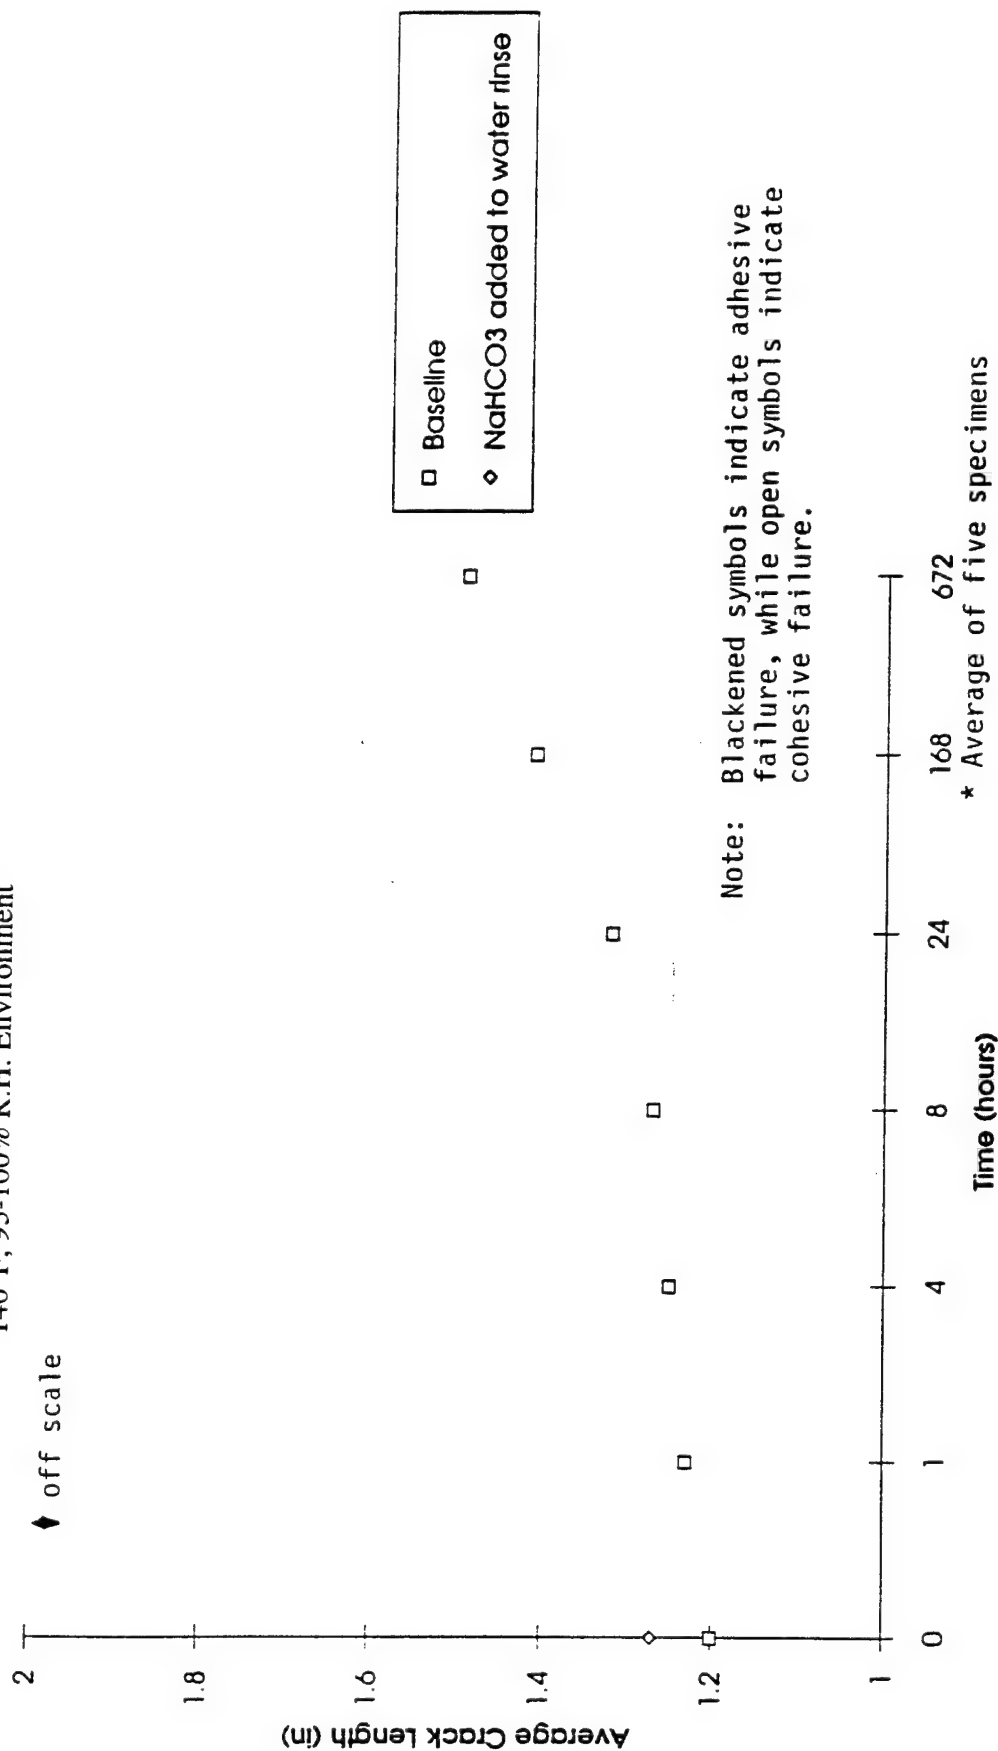
Figure 17. Effect of Sodium Bicarbonate (NaHCO₃) Added to Water Rinse on Crack Growth Behavior of PACS Prepared Surfaces

Al 2024-T3 Bare/BR 127/FM 73

140°F, 95-100% R.H. Environment

Figure 17 illustrates the effect of the addition of sodium bicarbonate to the last bottle of rinse water. The addition of sodium bicarbonate to the rinse water cycle resulted in unacceptable crack growth. This was investigated as a means of insuring neutralization of the liquid left in the bagged setup after completion of the process. It has been found that use of water alone for rinsing results in a final pH of 3-4 if one container of water is used and a pH of about 5 if two containers are used. Since a pH level of 5 is not considered hazardous to human contact, the recommended rinse/neutralization procedure is to use two containers of water.

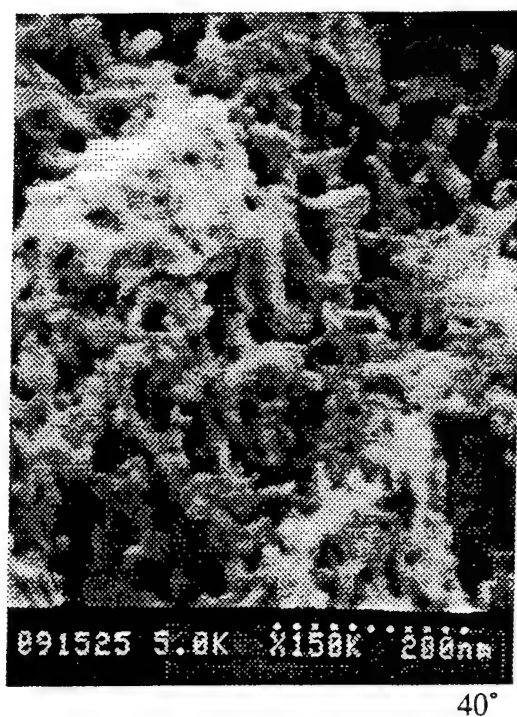
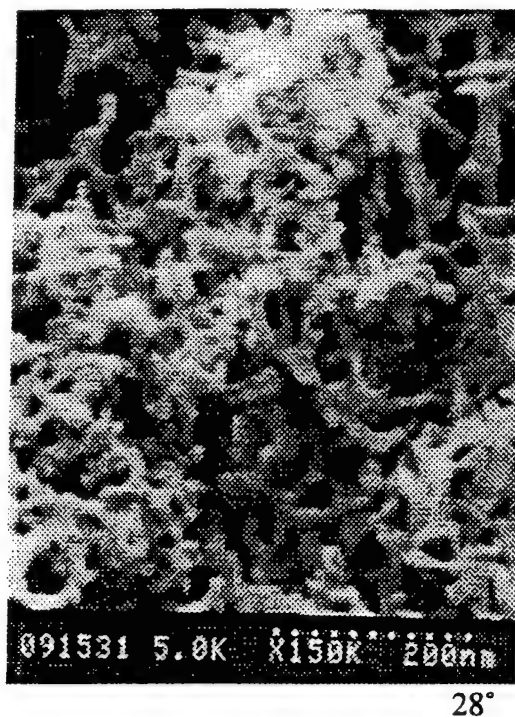
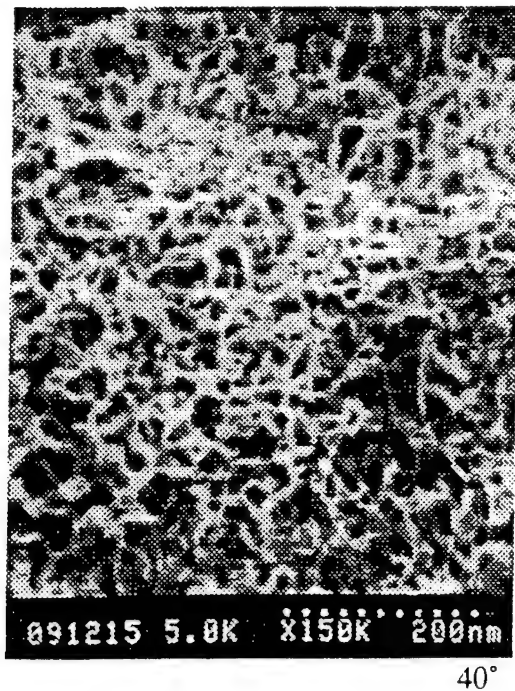
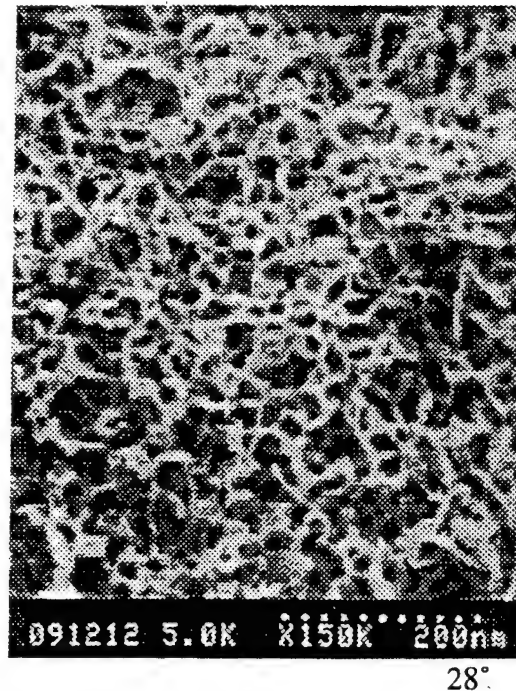
Figure 18. SEM Stereo Pairs of Anodized 2024-T3 Clad Aluminum (150,000X)

(a) Anodized with Tank PAA Procedure

(b) Anodized with PACS Procedure

Aluminum panels for surface morphology comparisons were anodized utilizing both the PAA and PACS surface preparation techniques. Stereo pair photographs of the anodized surfaces were obtained to determine and quantify surface morphological features. Comparison of the PAA and PACS oxide structures by this means indicated that while they are similar, the PACS structure exhibits finer features than the PAA prepared surfaces. Stereo pairs of PAA and PACS prepared 2024-T3 clad surfaces are presented in Figure 18. Very similar structures were observed with 7075-T6 bare and 2024-T3 bare. Examination of the oxide layer on both PAA and PACS prepared surfaces indicate a honeycomb structure with finger-like protrusions emanating from the corners of each cell. Visually, the differences seem limited to the diameter of the honeycomb cell. Figure 19 illustrates an isometric drawing of the oxide layer formation for both surface preparation techniques. Similar structures have been reported previously for the PAA surface preparation techniques. Although the structure is similar, the magnitudes of X, Y, and Z are different for the two techniques. Table 7 lists the dimensional measurements of the oxide layer including the values of X (Finger Height), Y (Finger Thickness), and Z (Honeycomb Cell Width) for both the PAA and PACS prepared surfaces. This table includes dimensions for not only the standard PACS and PAA prepared surfaces, but also PACS prepared surfaces where selected processing variables were changed. The results in Table 7 indicate that in general, the finger height is slightly longer for the PAA prepared surfaces, the PAA finger thickness is two times that of the PACS, and the PAA honeycomb cell width is 1.5 times that of the PACS. Two PACS anodized surfaces, 100°F and 100°F with a 5 minute water rinse delay, exhibited alterations of the oxide layer formation on the aluminum surface in addition to poor wedge crack properties previously reported. It was noted that there were significantly fewer honeycomb areas on the specimen anodized at 100°F than the standard specimen. In addition, there were no distinguishable features on the surface of the aluminum anodized at room temperature with a 5 minute water rinse delay.

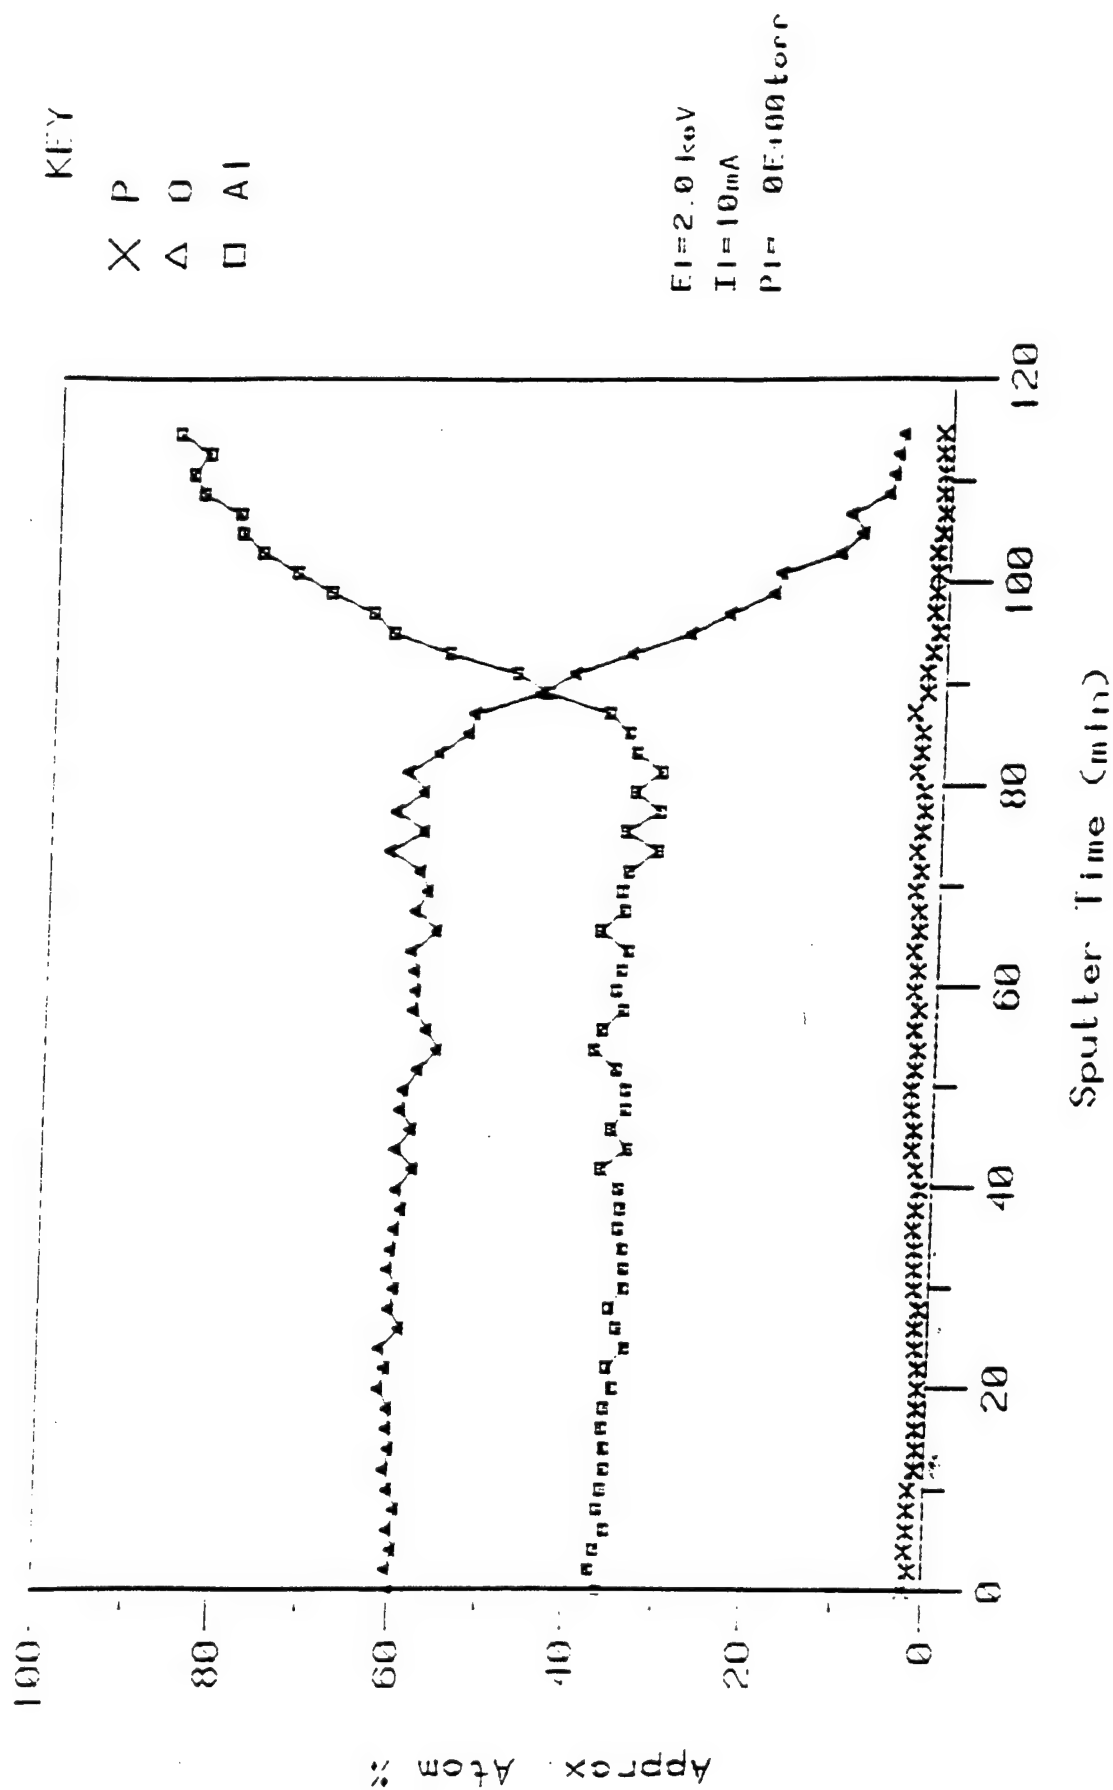
Figure 20. Depth Profile Analysis Using Auger Electron Spectroscopy for PAA Prepared Aluminum Surface

The sputter rate used for this analysis was 5 nm/min. The point at which the curve for aluminum and the curve for the oxygen cross indicates the time required to remove the oxide layer. With a crossover point at 90 minutes, the calculated overall thickness of the oxide layer is 450 nm (\cong 4500 Å). Similarly, Figure 21 illustrates the depth profile analysis for a PACS prepared aluminum surface. With a crossover point at 18.5 minutes and a sputter rate of 5 nm/min, the calculated overall thickness of the oxide layer is 92.5 nm (925 Å).

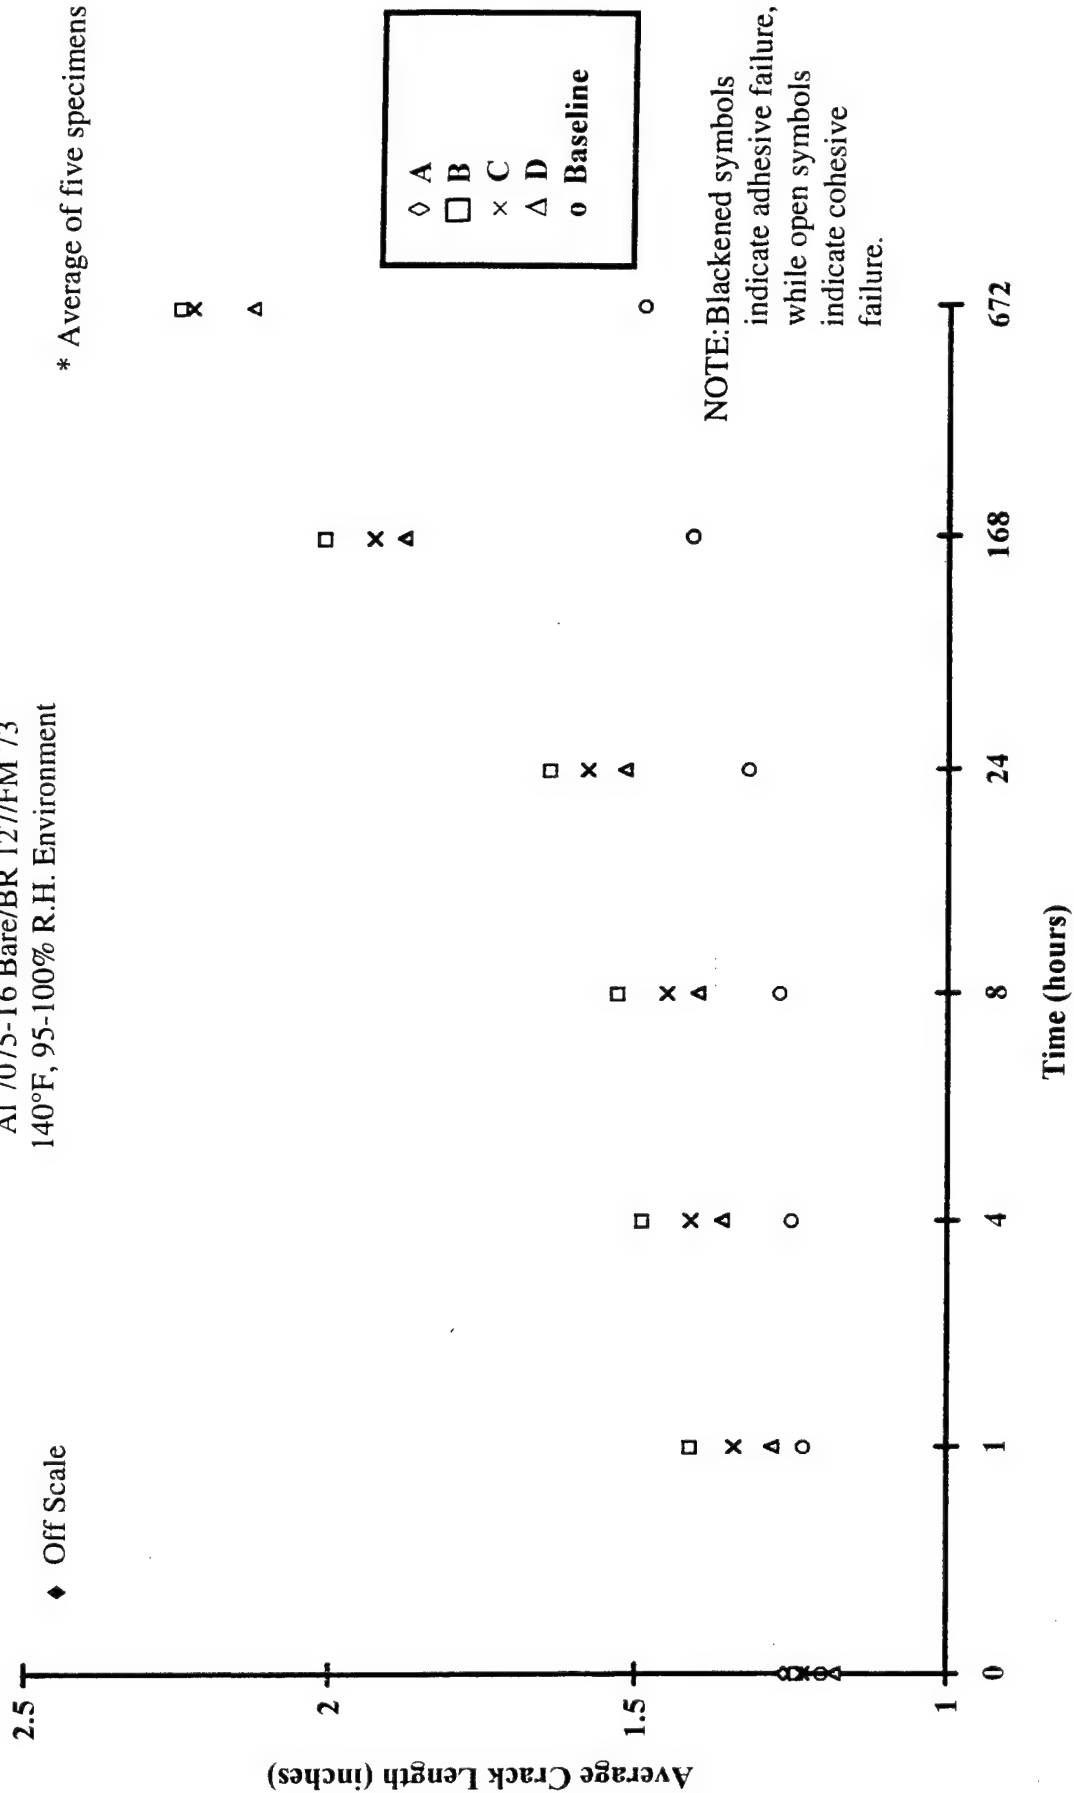
Figure 22. Average Crack Growth Curves Comparing PACS Prepared Surfaces by Specific Depots.

♦ Off Scale

* Average of five specimens

Wedge test panels were prepared and tested as discussed in Section 2.2. 7075-T6 aluminum was used for all panels. All the panels were primed with BR 127 and bonded with FM 73. The wedge test results are presented in Table 9. Graphical representation of these results is illustrated in Figure 22. With the exception of specimens removed from Panel A, all specimens exhibited cohesive failure.
